TECHNICAL REPORT CERC-87-12

# HURRICANE KATE STORM SURGE DATA

Report 5

Coastal Engineering Research Center

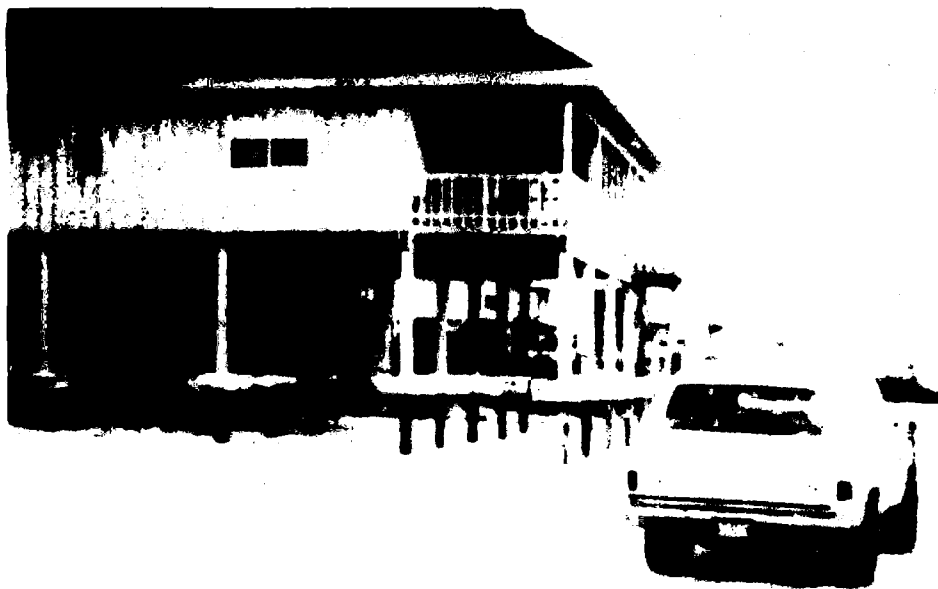
16. Property damage within the park was confined to boardwalks (Photo 6) due to the lack of construction along the beachfront. Farther south at Cape San Blas, there was more extensive damage. Several homes were totally destroyed (Photo 7), and houses that survived were undermined by beach erosion (Photo 8). The surge elevation at this location was approximately at 9 ft. Many of the buildings located far enough from the beach to be protected from surge damage suffered wind damage (Photo 9).

Photo 8. Beach erosion under house, Cape San Blas, Fla.

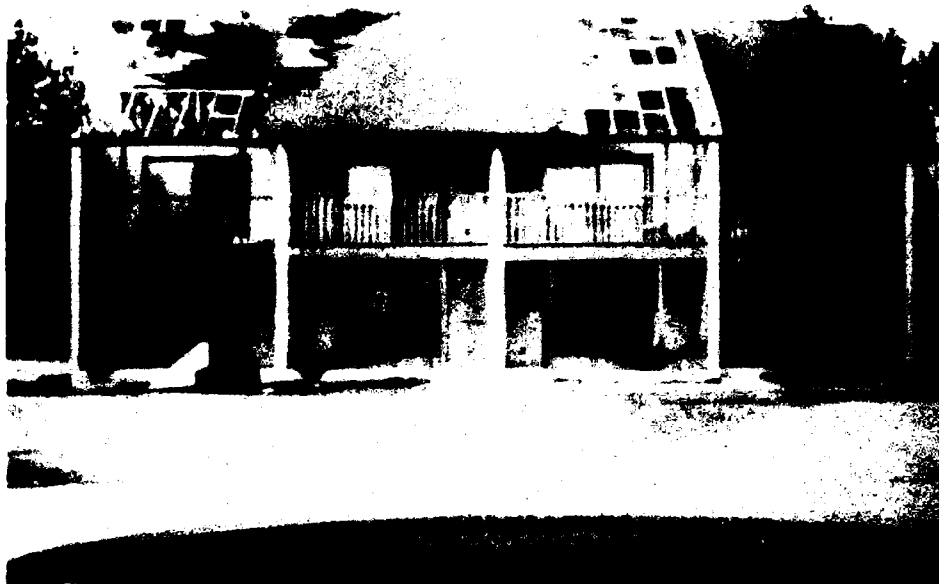
Photo 9. Roof damage, Cape San Blas, Fla.

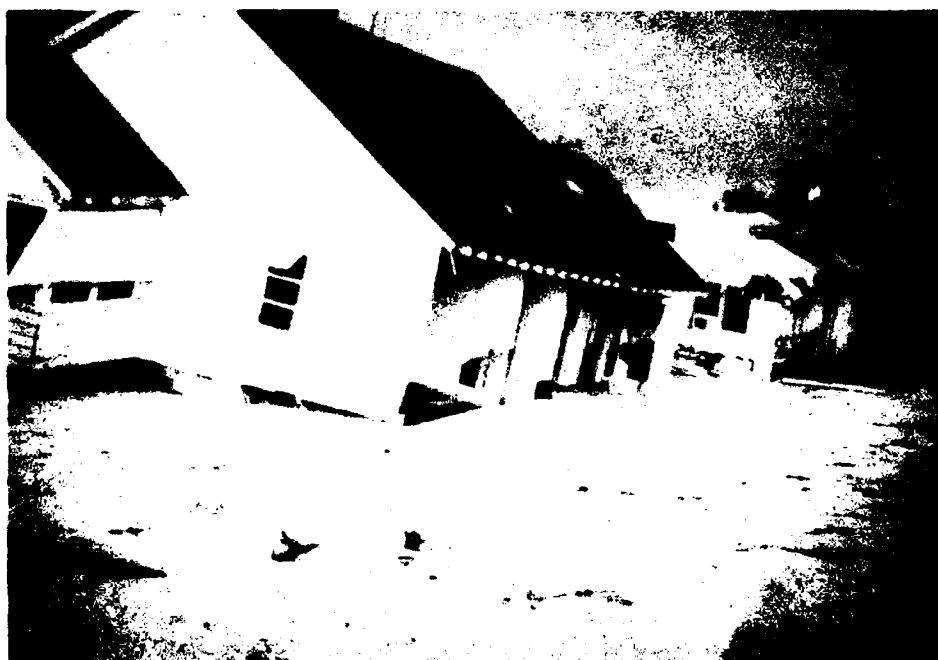
Photo 16. House destruction, Lighthouse Point, Fla.
